Applicable Airworthiness Directives

ID No: 17242

Model: 35-33, S/N: CD-174, Tail No: N5481

AD NUMBER	TYPE*	SUBJECT	Supersedes AD Number	N/A**
		ENGINE(s): IO-470-K SER# 86103-1-K		
		PROPELLER(s): F12A-4 IF 169 IF 170		
		MAGNETO(s): Slick R= 0113212 L= 0113210		
62-08-03R1	R	WHITE PLASTIC RAMS HORN CONTROL WHEELS		N/A
65-14-01	R	ALTERNATOR SUPPORT BRACKET		N/A
67-01-04	N	SUPERIOR FLOW OIL FILTER		N/A
70-03-05R2	N	TURNING TYPE TAKEOFFS PLACARD IN PLACE		✓OK
70-14-07R2	N	CONTINENTAL ENGINE N/A BY FUEL PUMP MODEL		N/A
72-11-02	N	ENGINE FUEL INTERRUPTION YELLOW BANDS IN PLACE		✓OK
74-18-05	R	SLICK MAGNETO N/A BY MAG MODEL #'S	74-08-05	N/A
75-05-02	R	AIR OIL FILTRATOR		N/A
75-15-08R1	R	BERYL AIR-OIL FILTRATOR		N/A
76-02-07	R	PRESTOLITE ALTERNATOR		N/A
76-07-12R1	NR	BENDIX IGNITION SWITCH OP'S CK'D. 8-15-07		✓OK
79-05-09	N	CONTINENTAL ENGINE N/A BY ENG. MODEL + SER #		N/A
79-18-05R1	N	LITHIUM BATTERY	79-05-02	N/A
80-06-05	N	SLICK MAGNETO N/A BY MAG. MODEL #'S		N/A
80-16-05	NM	SKY-OX OXYGEN REGULATOR		N/A

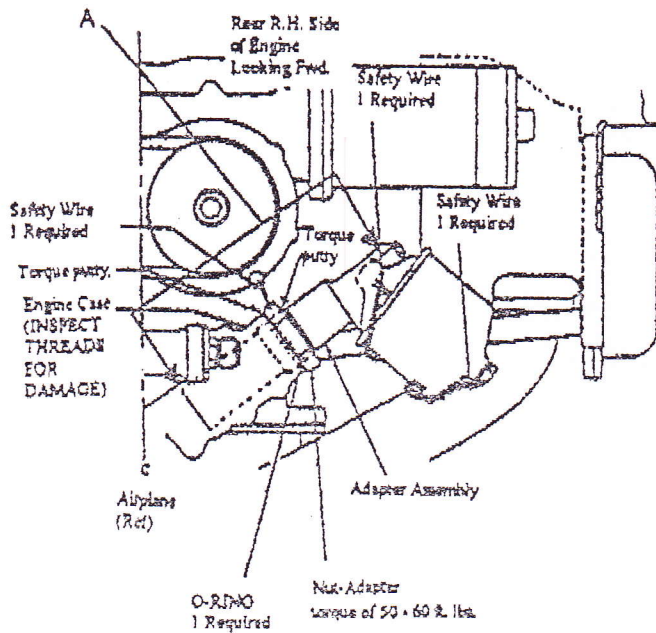
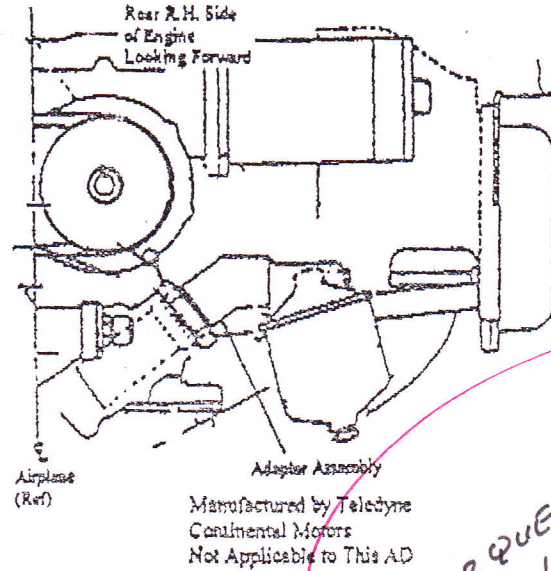
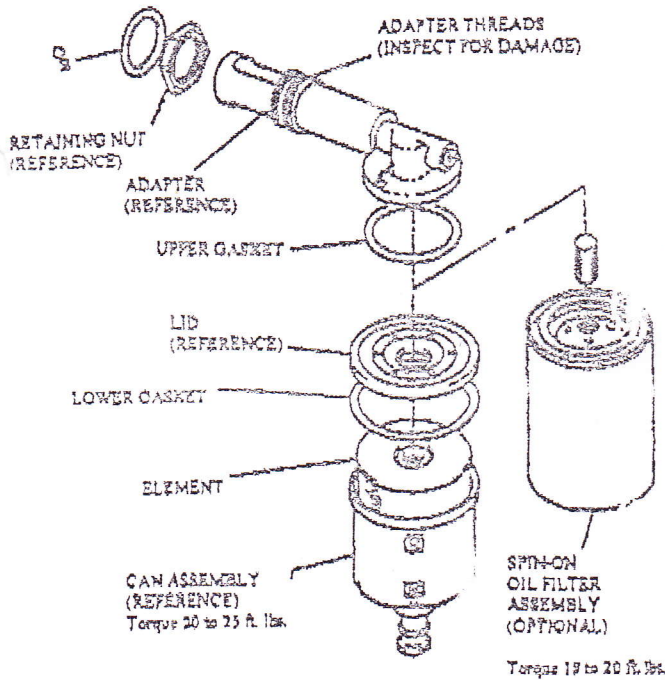
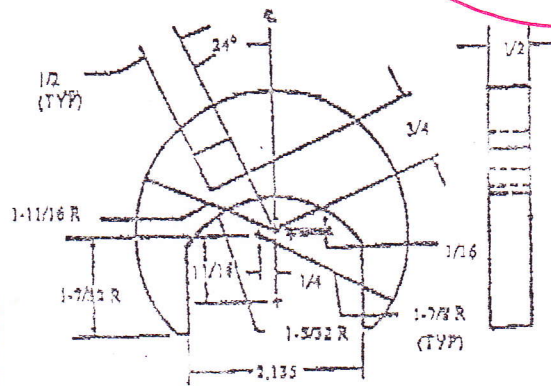
AD 96-12-22
1N-FO

- To prevent loss of engine oil caused by loose or separated oil filter adapters, which could result in engine stoppage while in flight and loss of control of the airplane, accomplish the following:
- (a) For airplanes with engine oil filter adapter assemblies that do not have torque putty between the engine filter adapter assembly, nut, and oil pump housing, accomplish the following:

- (b) For airplanes with torque putty between the engine filter adapter assembly, nut, and oil pump housing, inspect the torque putty for misalignment, evidence of oil leakage, or cracks.

- (3) If evidence of oil leakage is found or the torque is not within the 50 through 60-foot pound limit, prior to further flight, remove the adapter and filter assembly, and:

- (ii) Replace any adapter assembly and engine oil pump housing (if necessary) that have evidence of thread damage or cracks.

TORQUE VALUE.
50-60 LBS.

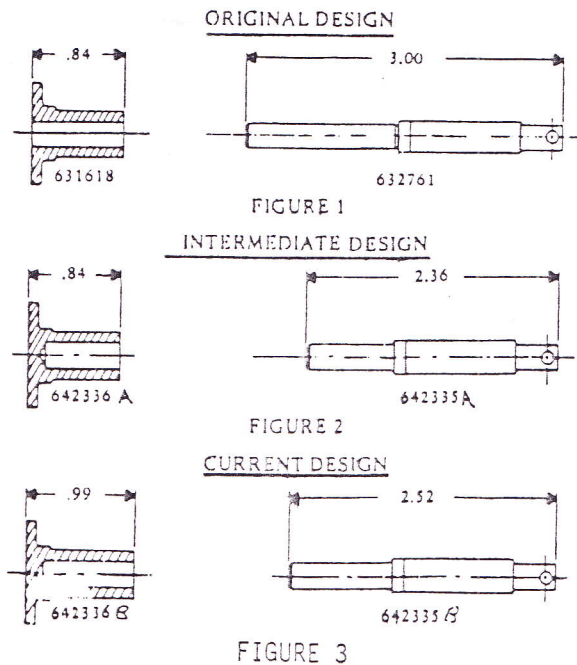
(2) Those screws and plungers which conform dimensionally to Figure 2, "Intermediate Design," must be replaced with components conforming to Figure 3, "Current Design." The "Current Design" is contained in TCM Kit 642335KA1. Screws and plungers conforming to Figure 1, "Original Design," may be continued in service.

(4) Identify the oil pressure relief valve housing with a yellow dot on those valves with plungers installed in accordance with Figures 1 and 3.
